FieldNOTE

An Update
on NASA's
Cleanup Efforts at
Santa Susana
Field Laboratory

NASA COMPLETES BMP CONSTRUCTION

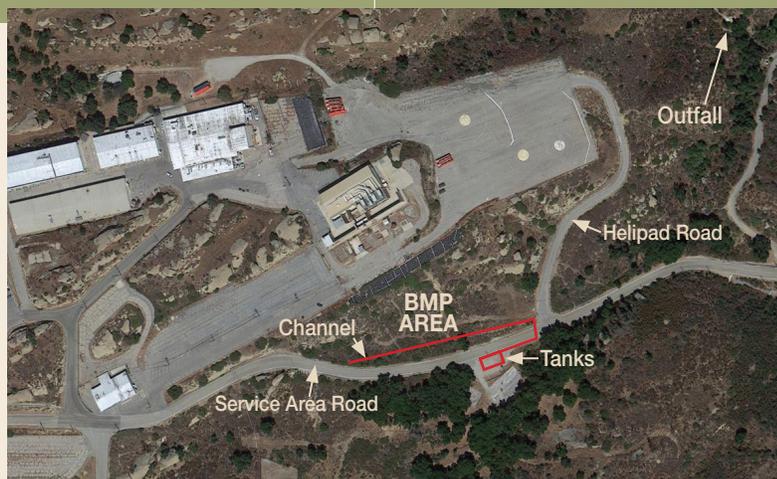
NASA decided to move forward with an Expert Panel recommendation and worked with the Panel to design a BMP focused on the hillside below the ELV (Expendable Launch Vehicle) site in Area II. [See aerial photo.] "Being a good steward is important to us and we wanted to do our part to help Boeing meet their stormwater permit obligations for the Site," said NASA SSFL Project Manager Peter Zorba. Implementing NASA's BMP will effectively capture, control, and mitigate stormwater runoff, and thus reduce the potential for COCs to be carried from the ELV hillside site to Outfall 009 during storm events. ■

NASA took action to improve stormwater quality by completing a BMP on the hillside below the ELV site in Area II.

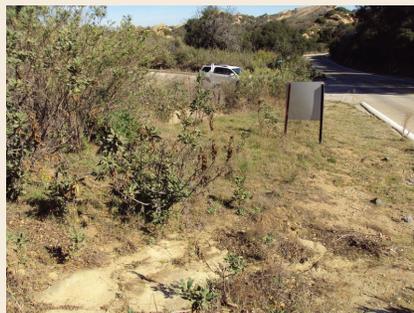
first The first step was to rehabilitate a dilapidated asphalt-lined drainage channel that runs approximately 600 linear feet along Service Area Road. The channel was originally intended to collect water from the roadway, the nearby parking lots, and the adjacent hillside, and then to convey water to Outfall 009. Due to the broken asphalt and overgrown vegetation in the channel, stormwater, instead of being captured in the channel, was seeping into the ground beneath the channel and then running onto Service Area Road. There, the water would entrain and transport sediment further downstream towards Outfall 009.

Drainage before construction.

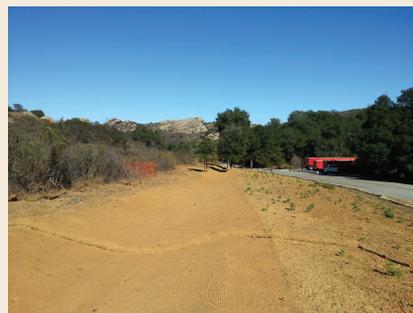
The broken asphalt was removed and the channel was re-graded and then sculpted to enhance and contain the downhill stormwater flow. A layer of hydroseed was put down in and adjacent to the channel. NASA used a seed mix of plant types native to SSFL that was recommended by the Stormwater Expert Panel. A permeable geotextile mat was installed in the channel to hold seeds and soil in place while allowing for

incidental infiltration and vegetation to grow up through the lofty weave of the fabric. [See photo.] Another layer of hydroseed was placed on top of the mat and soil along the channel. With this work completed, stormwater runoff from the adjacent hillside is contained within a more environmentally friendly channel bringing the water to the system collection area near Helipad Road.

Drainage after construction.

The mat keeps soil in place. Plants grow through the mesh.
