# Santa Susana Field Laboratory

## The Use of Trichloroethylene at NASA's SSFL Sites

This provides information on the cleanup of NASA properties at the Santa Susana Field Laboratory (SSFL).

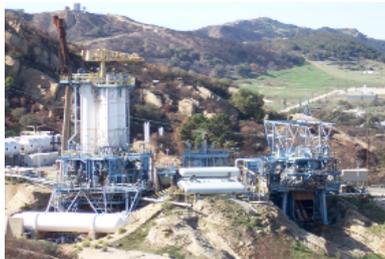
The Bravo Test Stands (including those pictured above) were among four areas NASA used for testing rocket engines.

NASA used Area II to conduct research, development and testing of rocket engines associated with the Apollo and Space Shuttle Programs. Area II contained four locations known as "test areas," most built between 1954 and 1964. These were open-framed, metal structures with concrete foundations, as well as related buildings. Each of the stands - known as Alfa, Bravo, Coca and Delta - had three or more "test positions" (also often referred to as test stands) for firing the engines. Use of most test stands was largely curtailed after the 1960s, but Coca Test Stand #4 was used extensively in support of Space Shuttle Main Engine research and development in the 1970s and early 1980s. All testing has ceased.

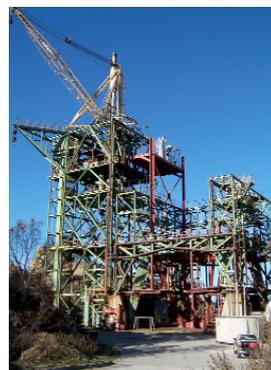
Coca Test Stand #4 was used during Space Shuttle Main Engine testing.

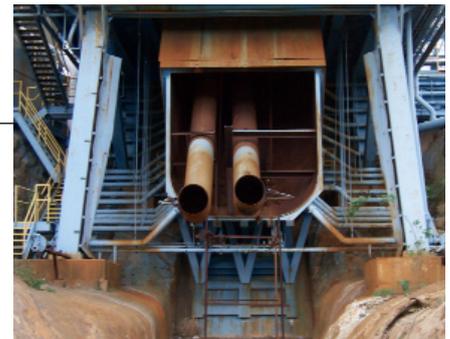
**After 1961, a TCE Recovery System was put in place. This diagram shows the system at the bottom of a test stand.**

A conical pan acted as a funnel collecting the flushed TCE. The TCE drained through a hose into a storage tank and then it was sold to a vendor for recycling.

From 1954 through 1993, there were more than 21,500 kerosene-fueled rocket engine test firings at SSFL that required TCE flushing, most of them in Area II. The majority of tests (95%) took place between 1955 and 1966. During the entire testing period for kerosene-fueled engines, some 500,000 gallons of TCE were released into the ground with the vast majority (97%) occurring before 1961. Prior to that year, the TCE used to clean engines ran down into a concrete spillway, which led to unlined ponds and some of the TCE spilled into the soil, eventually making its way into groundwater. Several ponds were subsequently excavated and backfilled. In 1961, the USAF instituted a TCE recovery system, consisting of “catch pans” located at each test position, which were connected by hose and pipeline to a collection storage tank. This TCE was later sold for recycling.
